# *Foreign Technology Division*

## **HAVE DRILL/HAVE FERRY - EXPLOITATION OF THE SOVIET MiG-17F**

**Rob Young  
Historian  
National Air and Space Intelligence Center**

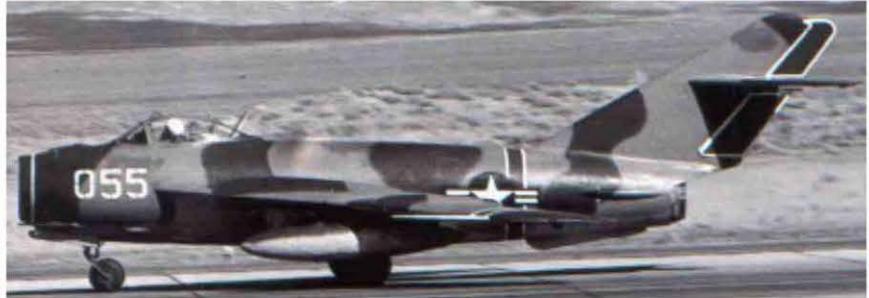
- **HAVE DRILL**
- **Instrumented**
- **Periscope**
- **SCAN FIX radar**
- **172 sorties**

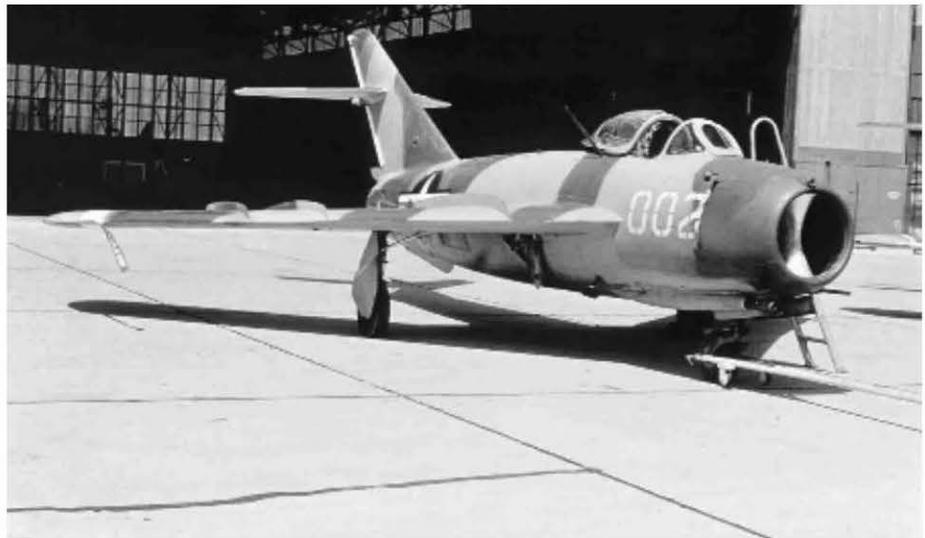
- **HAVE FERRY**
- **Back-up A/C**
- **No Periscope**
- **No radar**
- **52 Sorties**

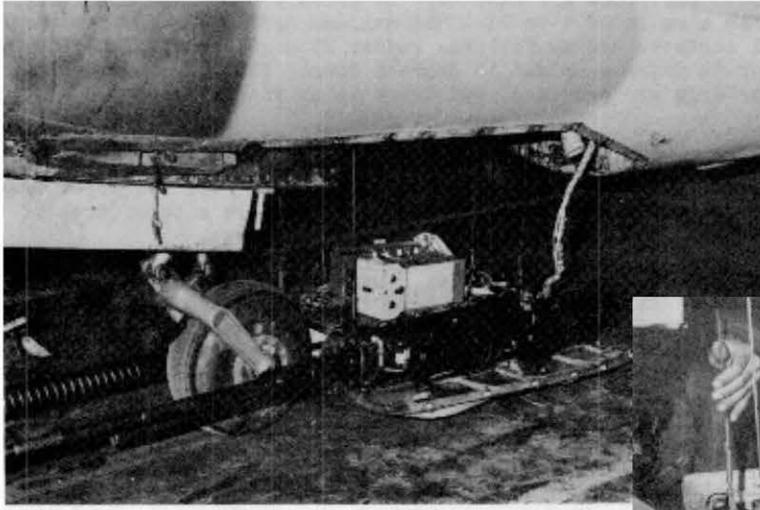
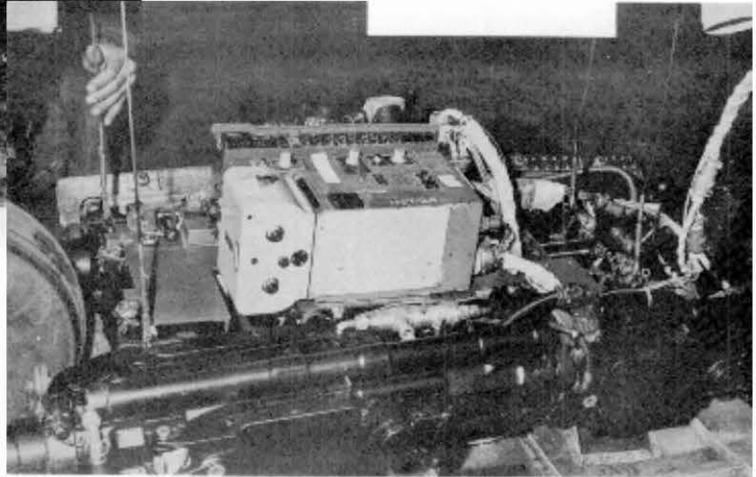
Figure II-3 Fresco C Gun Package-Lowered

-14-channel oscillograph mounted in gun platform where ammo boxes were. It weighed 75 pounds

-Recorded fuel flow/temp, OAT, engine RPM, airspeed/altitude, control surface positions, attitude, roll-pitch-yaw rates, acceleration and the EVENT button

OSCILLOGRAPH FOR RECORDING FLIGHT TEST DATA

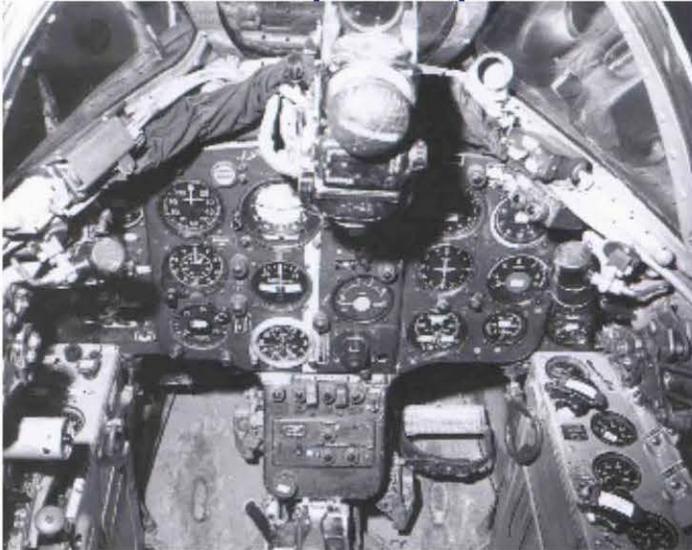
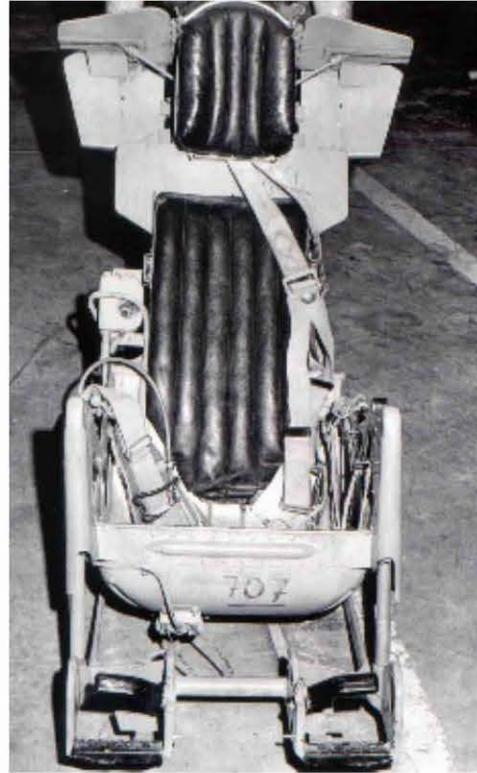
- Antiquated design
- Cramped for a man over 6 feet and the seat was not adjustable
- Excellent periscope

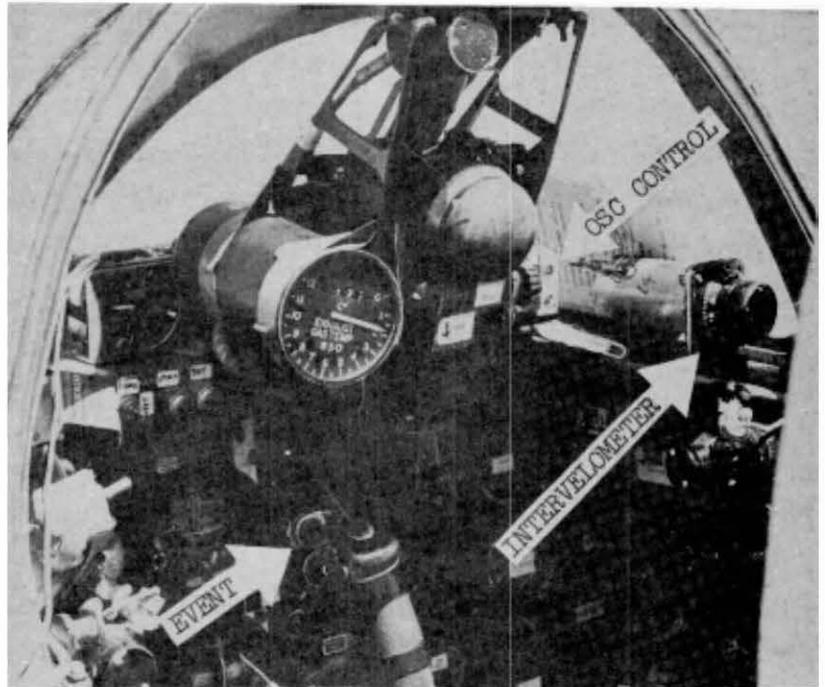
COCKPIT INSTRUMENTATION CONTROLS

- G meter
- Intervalometer
- Airspeed
- Altimeter
- Machmeter
- EGT/Tach
- Tape recorder
- UHF radio
- OSC/Event
