# Damage assessment on buildings using very high resolution multimodal images and GIS

A.-L. CHESNEL<sup>†</sup>, R. BINET<sup>†</sup>, L. WALD<sup>‡</sup>

## Abstract

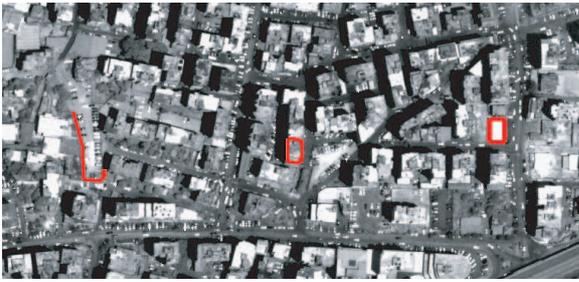
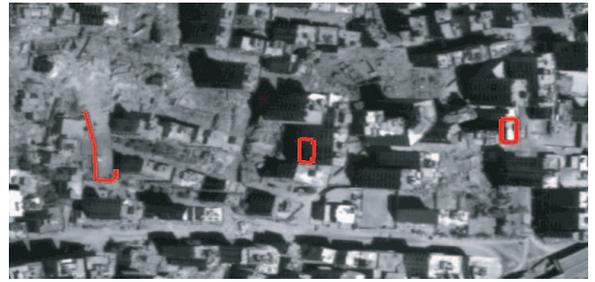
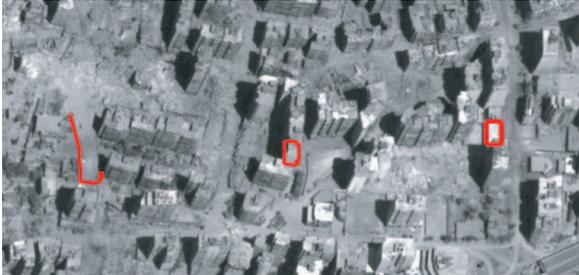
(a) Reference image (19 June 2006)

(b) Crisis image (9 August 2006)

(c) Crisis image (12 August 2006)

Figure 1: In red, three marks are drawn in (a): on the ground (left), on the roof of a high building (centre) and on the roof of a low building (right). They are reported in the crisis images (b and c) using the geographical coordinates. The mark on the ground (left) is correctly registered for both crisis images, whereas the buildings roofs are shifted. – Note in (b) that the low building on the right is hidden by another one.

First, we note that none of the available images have the same acquisition parameters (table 1). This is confirmed by the table 2: the B/H ratio varies from 0.42 to 1.40; it represents absolute difference angles from 24.3° to 80.1°. Note also that the two first crisis images (22 July 2006 and 9 August 2006) present very low elevation angles. This is often the case for the very first images acquired after a disaster, because they are acquired as soon as possible, without waiting for ideal conditions. Figure 2 illustrates the problem of registration with the reference image of 19 June 2006 (a), and the crisis images of 9 August 2006 (b) and 12 August 2006 (c). The three images are registered according to the ground, as confirmed by the red mark on the left: it is at the same location in the three images. A high building in the centre is highlighted: the higher the B/H ratio, the larger the shift between the two images. We also see that a low building (on the right of the images) can be hidden by a higher one (figure 2b), preventing its analysis.

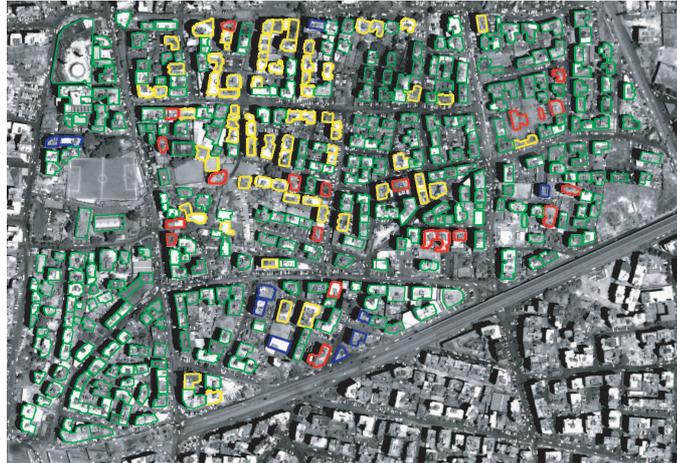
Figure 2: Area of Haret Hreik, in Beirut, Lebanon. Image acquired in 19 June 2006 (reference image). The footprints of the 430 buildings contained in the GIS, used as additional input, is overlaid. The green corresponds to intact or not detectable damage (325 buildings); the yellow to buildings destroyed between the 19 June 2006 and the 22 July 2006 (74 buildings); the red to buildings destroyed between the 22 July 2006 and the 9 August 2006 (21 buildings); the blue is for buildings destroyed between the 9 August and the 12 August 2006 (10 buildings).

The extraction of the building roofs is limited to the reference image; then the same GIS is used with the three pairs of images that correspond to the three crisis images. In this way, a monitoring of a site of interest at successive dates is possible. By comparison with the crisis images, we have identified the buildings of the area that have been destroyed. It will represent a ground-truth to which we will compare the result of our damage detection method. The GIS, overlaid on the reference

image is presented in figure 2.

First we register the images according to the ground (image registration). As seen in figure 2, the top of the buildings are still not registered: a method of subpixel registration of the building roofs is then applied, using the GIS (roof registration). The GIS is already registered to the reference image.

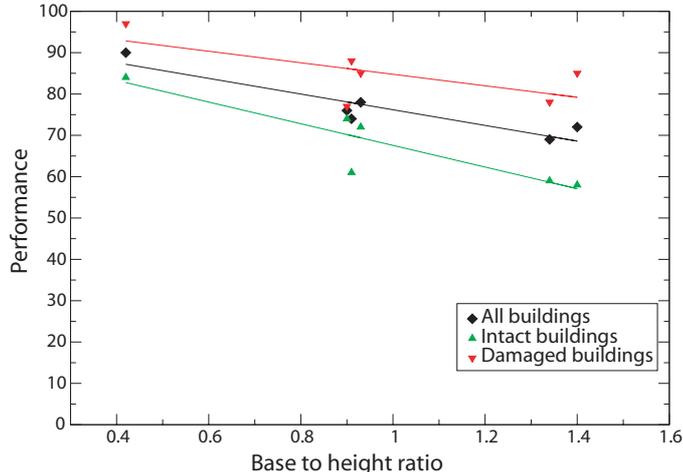
Figure 3: Rate of good classification for the buildings as a function of the B/H ratio. Lines result of a linear regression for intact buildings (green), destroyed buildings (red) and whole dataset (black).

The classification performances are given as a function of the B/H ratio in figure 3. The rates of good classification for the intact buildings and for the damaged buildings appear separately (respectively in green and in red), along with the mean performance (in black).

There is a clear trend of performance decrease when the B/H ratio increases (figure 3). Considering the intact and the damaged class separately, we observe that the damaged class is detected with a better accuracy than the intact one. Moreover, its associated performance is less affected by a high B/H ratio. Few damaged buildings are not detected. The main origin of the classification errors is false-alarms, i.e. the intact buildings that are classified as destroyed. A precise analysis shows that a large part of these errors are due to registration errors, for example buildings that are hidden by another one or located in its shadow. Figure 4 illustrates one of this situation. No information can be retrieve from these occluded buildings. We also point out that a lower satellite elevation leads to a coarser spatial resolution; a large difference of spatial resolution between the reference and the crisis image could also explain a decrease of similarity, even for intact buildings.

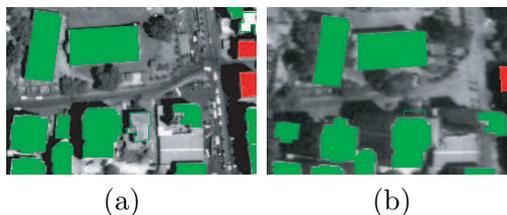
Figure 4: Classification result – Extracts of the 19 June 2006 reference image (a) and the 22 July 2006 crisis image (b). Green corresponds to intact buildings, red corresponds to destroyed ones; Solid fill means correct classification, contrary to the footprint with no fill. The building in the center is intact but is classified as destroyed because it is hidden by another building: an important change is detected.
